THE SULIS CLUB, CLAVERTON DOWN ROAD, BATH

Project: The Sulis Club

Title: Initial Preliminary Ecological Appraisal

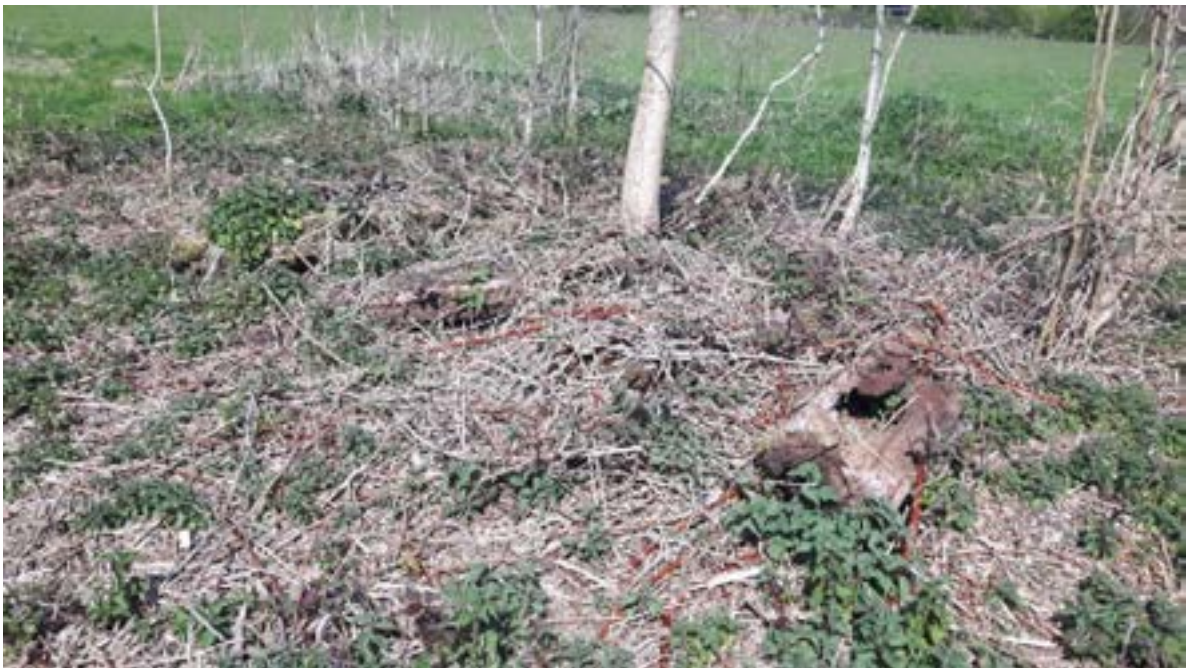
Plate 4: Japanese Knotweed and deadwood on the larger earth mound

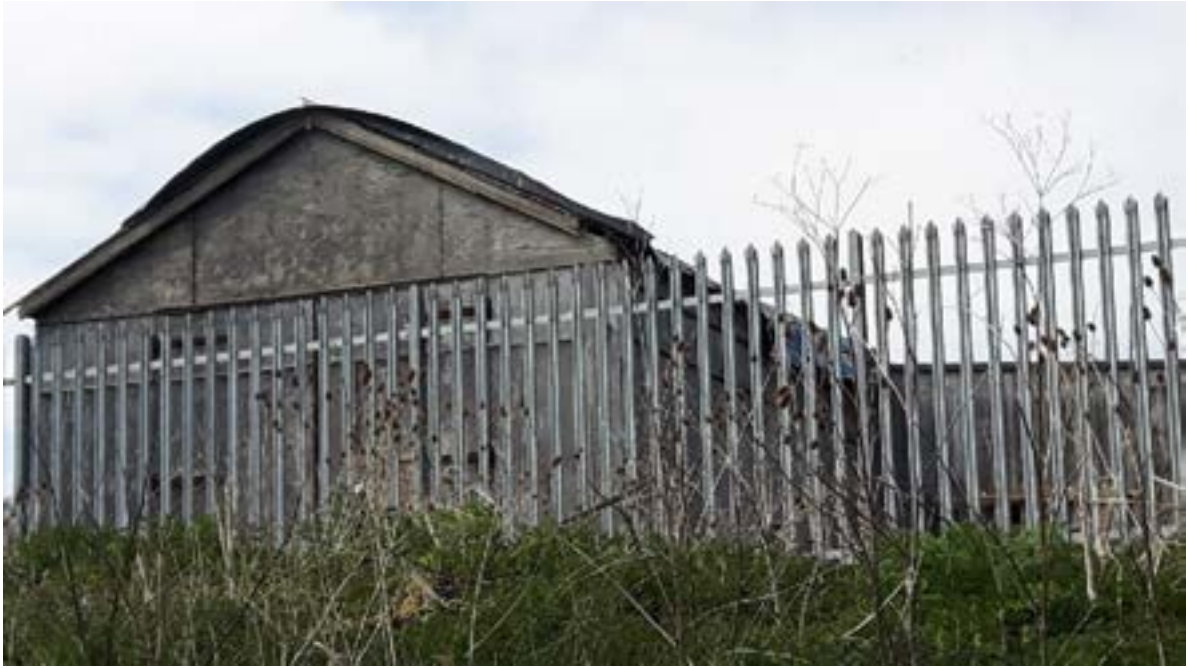
The majority of habitats within the Sulis Club including bare ground, buildings and amenity grassland provide very limited opportunities for wildlife. The buildings could not be fully assessed for their suitability for roosting bats, however the building to the south exhibited an entrance opportunity and has therefore been assessed as providing Low suitability for roosting bats (Plate 7).

Plate 7: Southern buildings with Low bat roosting suitability

Should a planning application be put together for the site a full Preliminary Ecological Assessment will be required, including a Preliminary Ecological Assessment for Bats on the buildings and trees and a full desktop study. It is likely the site will also require an update badger walkover, bat activity surveys, reptile surveys, a Precautionary Method of Working and a Japanese Knotweed Control Strategy.

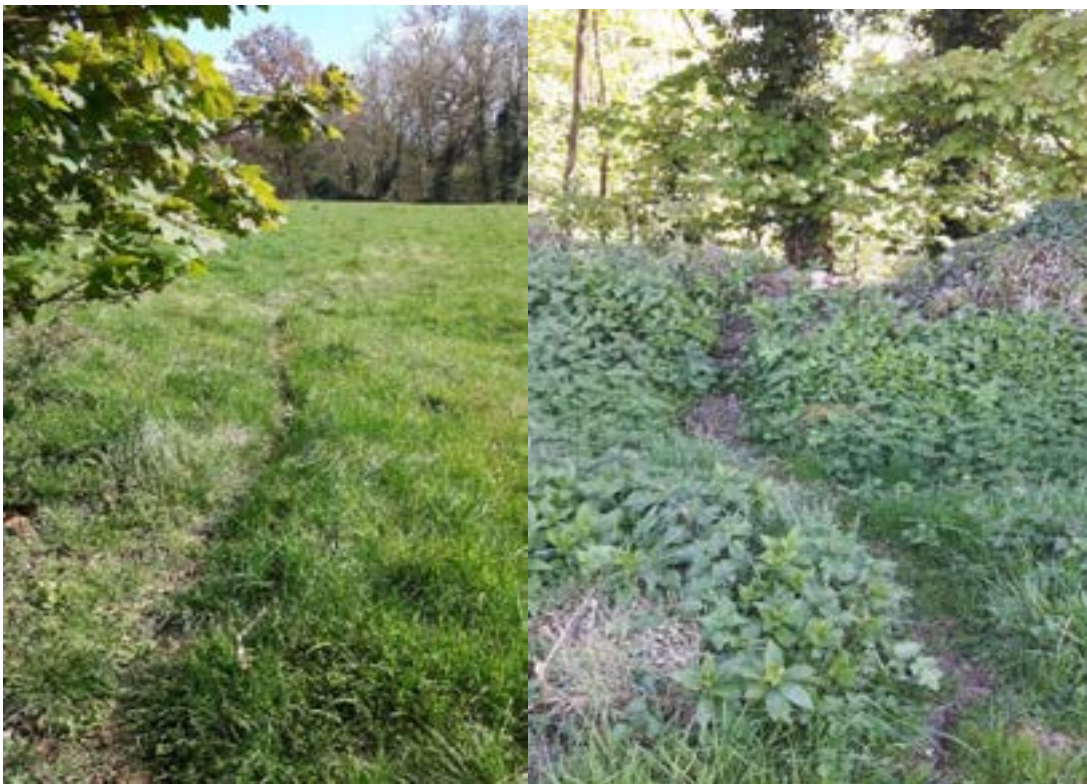
Semi-improved grassland and scattered scrub habitats provide opportunities for commuting and foraging badgers, whilst the south facing bank through the centre provides sett building opportunities. No evidence of setts was recorded during the survey, however mammal paths were identified (Plate 8). Due to the presence of the woodland adjacent to the southern boundary, it is likely badgers will utilise the woodland for sett building as it is subject to less disturbance and light-spill, and therefore provides better opportunities. There is evidence of well-used mammal paths entering the site from the woodland, as such it is likely badgers will utilise the site for commuting and foraging. A Precautionary Method of Working document will be required on site prior to any works commencing to ensure badgers are safeguarded against and potential works on site. An update badger walkover will also be required prior to works commencing to assess any further activity of badgers on site.

Plate 8: Mammal paths on site

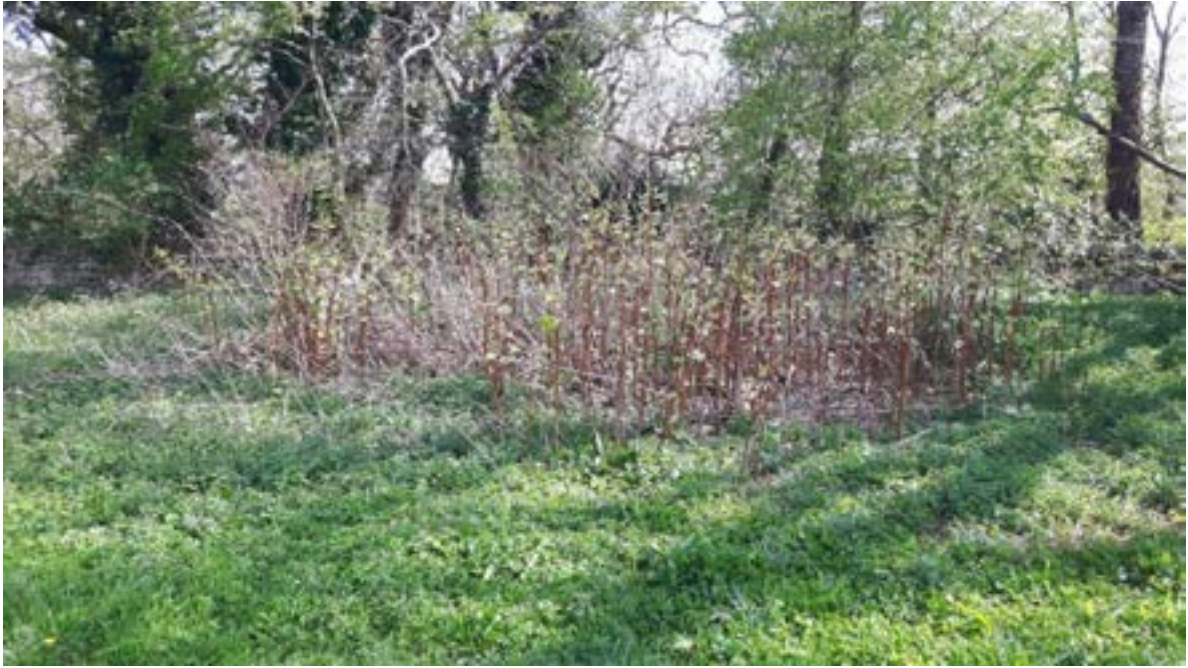
Japanese Knotweed was recorded on site within two areas along the southern boundary (Plate 9). Japanese knotweed is listed under Schedule 9 of the Wildlife and Countryside Act 1981 (as amended). It is an offence to plant or otherwise cause to grow in the wild any plant listed on Schedule 9 of the Wildlife and Countryside Act 1981 (as amended). Japanese knotweed is non-native invasive species, which out-compete native wildlife and spread rapidly. The species can also cause structural damage if not controlled correctly.

The underground rhizome system of Japanese knotweed can extend at least 7m from the parent plant, and reach a depth of 3m or more. A piece of rhizome the size of a little finger nail can grow into a new plant (Environment Agency, 2010). As such a Japanese knotweed control strategy will be required for the site.

Plate 9: Japanese Knotweed on southern boundary

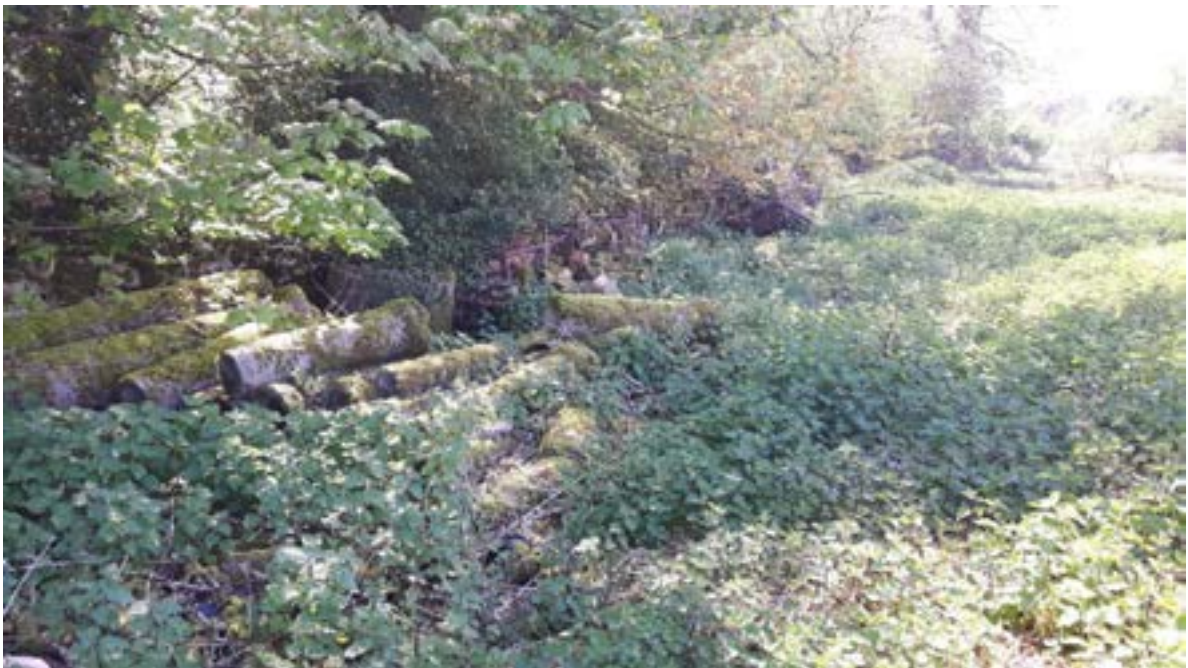
Plate 10: Possible asbestos pipes (as identified as T1 on Figure 1)

The possible asbestos pipes recorded within the southern area of the site will require assessment from a qualified asbestos surveyor, as well as appropriate removal (Plate 10).
