ANALYSIS OF JAMES DREDGE'S VICTORIA BRIDGE, BATH

R.A. Griffiths¹

¹University of Bath

Abstract: This paper examines the design of the hybrid suspension / cable stayed Victoria Bridge crossing the River Avon in Bath, England. This paper will study the suitability of the bridge to withstand the current day loadings imposed upon pedestrian bridges, and also seeks to appraise the bridge on an aesthetic level. It will discuss the history, present condition and future development of the bridge and its surroundings.

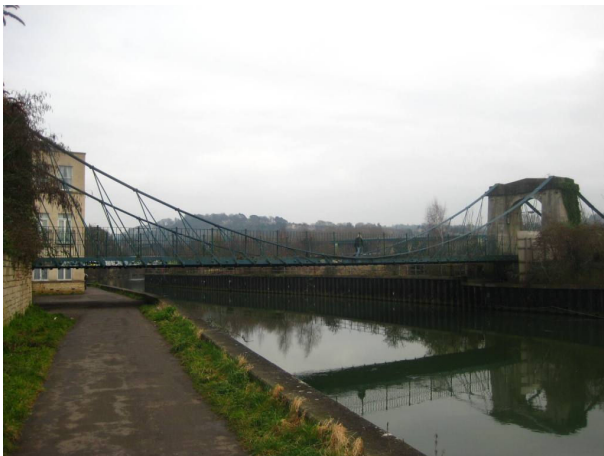
Figure 1: Victoria Bridge viewed from towpath

Victoria Bridge (Fig. 1), located near to the Royal Victoria Park in Bath, England, on first appearance looks like it could be a typical 19th century wrought iron suspension bridge. However Victoria Bridge has some key features which optimized the structure and make it more efficient, reducing the quantity of iron required, and speeding up the construction time.

Also, as is clearly evident in figures 1,5,6 and 8 there is a lot of graffiti on the piers, and the edge of the deck. It is worst above the towpath, as the bridge is within easy reach. But even in less accessible areas graffiti is present, as the chains are of a width that it is possible to walk up and down them.

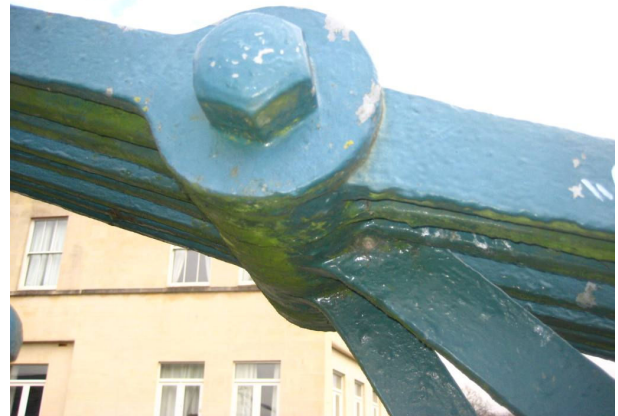
Figure 3: Bolted connection on the chain, note that the number of links reduces from 8 to 7 at this node

Each of the two main span chains consists of 155 individual wrought iron links, arranged in 19 sections. Each link is approximately 2.5m long and has a rectangular cross section of 55mm*15mm. The end of each link is circular with a shear pin running through it to join it to the next link (Fig. 3). Two inclined hangers come off the main chain at each joint to support the deck. The number of links used in each 2.5m stretch of chain varies from the pier to the central point. At the top of the pier the chain is made up from 12 links, which gradually decreases to 5 links at the central point., this is the taper principle.

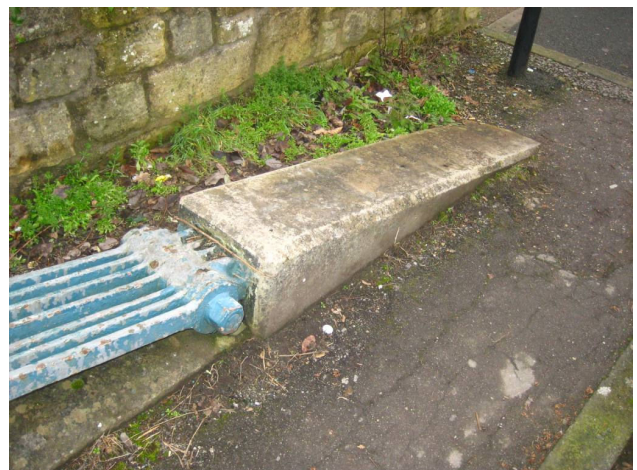
Figure 4: Anchor blocks at the southern end of the chain

The chains run over the top of the piers and down to the ground. The length of chain behind the piers is made up of 71 iron links, arranged in 8 sections. As in the main span the number of links in each section of chain decreases from 12 at the top of the pier to 7, where it is anchored into the ground. At each pin 2 inclined hangers come off the chain and are anchored into the ground, as a result the end anchor block is relatively small (Fig. 4).

Another element which looks quite out of proportion are the anchor blocks (Fig. 4). In a traditional suspension bridge they would be taking the load from half of a cable. In Victoria Bridge, hangers into the ground reduce the load in the cable as it approaches the anchor block. This means a smaller anchor block is needed.

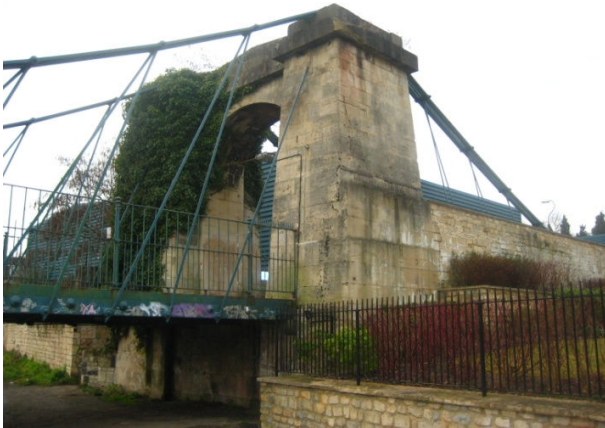
Figure 5: View of the northern pier

Each end of the bridge consists of two masonry columns 2.2m wide (perpendicular to span) and 3.4m deep. Each column tapers slightly towards the top, to complement the principle of the bridge. Each pair of columns is joined at the top by a masonry arch. The way the chain runs over the top of the piers suggests that the piers are not designed to take any considerable moment. However there is undoubtedly some moment introduced into the piers as the chain is not able to freely move over the top of the pier, also the first hanger is built into the side of the pier. (Fig. 5)

The only detail on the bridge which looks out of place is where the last hanger in the main span disappears into the pier (Fig. 5). This is unlike all the other hangers which clearly connect to the chain, and hence it looks out of place.

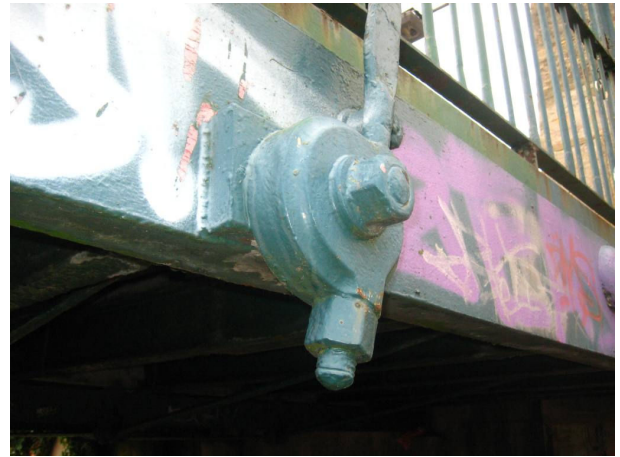
Figure 6: Hanger connection detail

At each node on the chain two inclined wrought iron hangers come off the chain to either support the deck or, beyond the piers, to dissipate the load into the ground. The cross section of each hanger is the same as that of each link in the chain 55mm*15mm. The angle of each hanger varies, where the angle of the hanger to the horizontal decreases towards the center so that “the obliquity, as well as the stress upon the chains achieves its minimum value.”[6] Each hanger connects to the edge beam of the deck at approximately 1.1m centres (Fig. 6).

The deck consists of timber planks, which span in the direction of the bridge. The roadway was originally stoned [4], but at some later date, most possibly in the 1946 renovation it was replaced with asphalt. The timber planks span in the direction of the bridges span, and are supported by, and stapled down to, I beams at 0.5m centres. These I beams span the entire width of the bridge and connected inside the parallel flange channels (PFC's), to which the hangers attach (Fig. 6)

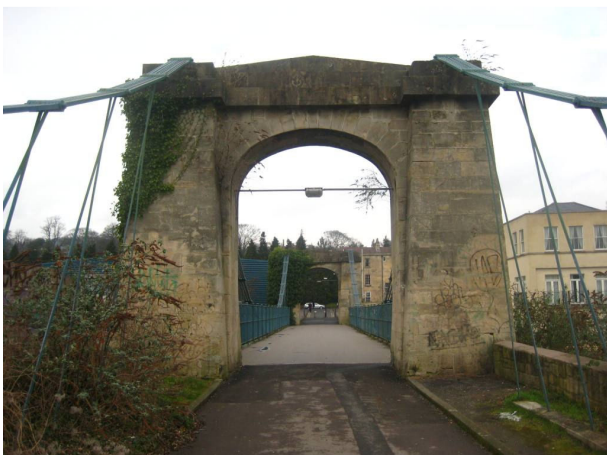
Figure 8: Southern approach

When you approach the bridge on foot from the ends, the density of bars in the balustrade obscures the view of the bottom quarter of the chains. (Fig. 8) This disguises the functional element of the bridge as discussed in 2.1.

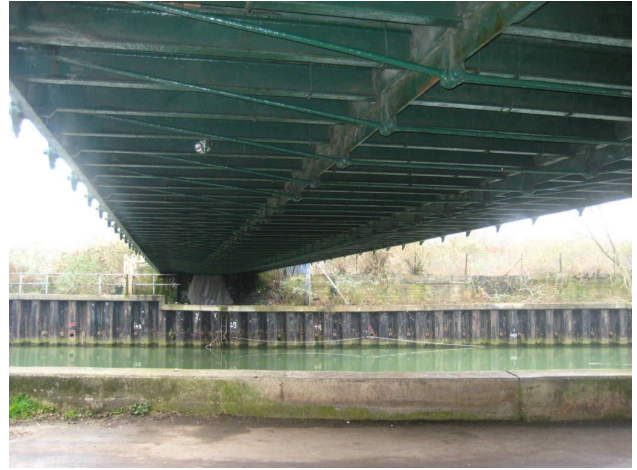
Figure 9: View of underside from towpath

The structure is highly ordered, connection are at regular intervals. Even under the bridge (Fig. 9) the regularity of the trusses and beams is aesthetically pleasing. The lines along the edge of the bridge are only broken by the protrusion of the connection detail (Fig. 6), but their order means they don't look out of place.

The modern day profile of the river is set by the sheet pile edging, as visible in Figure 9. These would not have been there in 1836 as they are most likely made of steel, which hadn't been invented. The historical map of the area shows a more natural profile to the edge of the river.

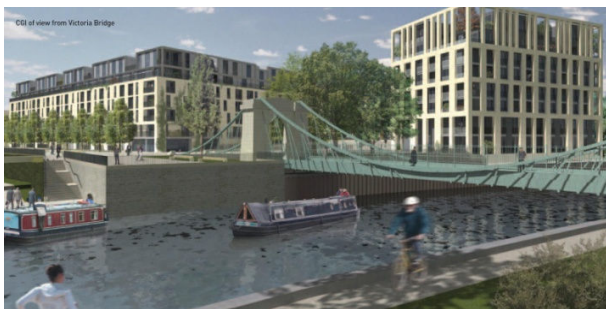
The computer generated image below shows how the bridge would fit into the surroundings. The image is taken from the summer 2007 brochure. Unfortunately the drawing of the bridge makes it appear unattractively disproportionate, as the deck has been drawn much too thick.

Figure 10: Computer generated view of current redevelopment plans

After the removal of all the graffiti and overgrowth, the bridge should act one of the primary pedestrian routes into the city centre from the development, with trees planted at both ends. A landing station for boats will be built adjacent to the bridge, meaning that the bridge will be viewable from river level. Hopefully increased awareness of the unique features of the Victoria Bridge will result in it becoming more of a landmark in Bath.

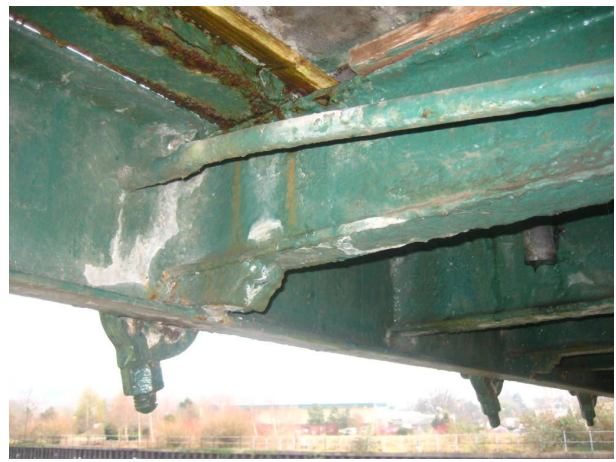
Figure 13: Corrosion to the underside of the deck above towpath.

The ironwork in the underside of the deck has suffered some considerable corrosion, and the surface of the iron is rough and in some places flakey. The repainting of the ironwork has helped in preventing further corrosion, as evident in Figure 13, only the underside of the box section supporting the balustrade (Fig. 7, Item 2) is currently suffering severe corrosion from water ingress down the side of the bridge surfacing. This is a considerable design flaw in the bridge, in that it does not feature a drainage channel anywhere on the deck. The impermeability of the surfacing means all water runs to the edge, but the upstanding box section at the edge means water must flow down between the timber and the box section. This allows a considerable flow of water to trickle down the ends of the I beams, as visible in Figure 13.

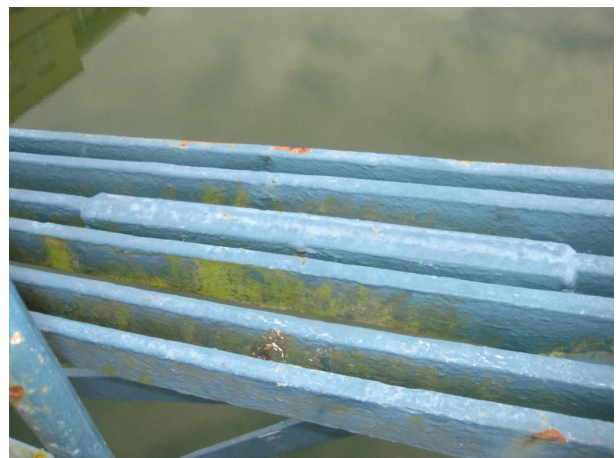
Figure 14: Algae, rust and repair to damaged link

The condition of the chain is generally good, some paint has started to peel off, which has led to the start of light corrosion to some links. Mould growth and algae growth on the underside of the chain is also evident on most of the chain. The structural condition of the links has also been checked at some stage, as there is a repair to one of the links, as shown in Figure 14. The damaged link has had two equally sized iron bars welded to either side of the link. The fact that only one link has needed repair, out of hundreds on the bridge is testament to its ongoing durability.

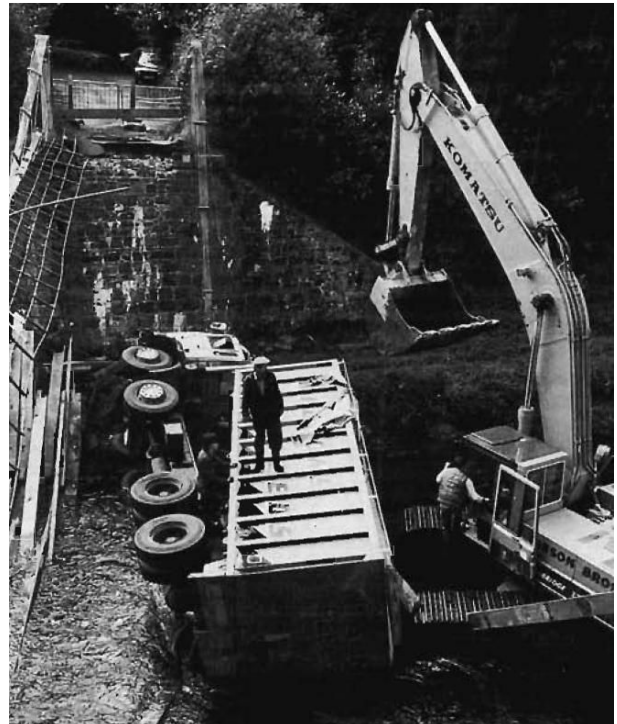
Figure 15: Death of Ballievy Bridge (from Ref. 7)

Figure 15 below shows what happened when a overweight vehicle is driven onto a Dredge bridge. This unfortunate accidental loading happened to the Ballievy Bridge in Northern Ireland. It was functioning as a public road bridge up to the 12th of September 1988 when a 27t lorry got lost and attempted to cross the bridge, despite weight limit signs.

The damage was so extensive that the bridge could not be repaired. The remains of the bridge are held in storage. [7]

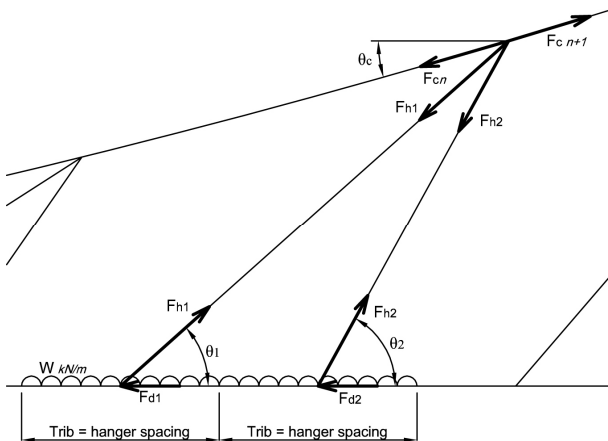
Figure 16: Forces in the bridge deck, hangers and chain

With reference to Figure 16, it can be assumed that the loading on the deck is transferred to the edges, and can be assumed to act as a line load (W). For the worst case loading condition described above, W is 22.2kN/m at ULS. The force transferred into the hangers (F_h) varies depending on the obliquity of the hanger (θ), the resulting compression force in the deck (F_d) is also dependant on the obliquity of the hanger.

By tabulating the calculation, the forces in each section of the chain was found to vary from 234kN at the central section, to 1570kN at the top of the pier, with an increase of 167kN at each node in between. At the centre there are 5 links in the chain, each link takes $1/5^{\text{th}}$ of the load, which is 47kN. At the pier there are 12 links in the chain, each link takes $1/12^{\text{th}}$ of the load, which is 131kN, these links have the highest load. Given that the link cross section is 55mm by 15mm, it can be deduced that the max stress in the links is $131,000/(55*15)=159\text{N/mm}^2$. Taking the modern value for ultimate yield stress of 340N/mm^2 gives a factor of safety of 2.14 at ULS. Given that the ironwork is old, has deteriorated slightly and will not have been manufactured to modern standards, a factor of safety of nearer 4 may be preferable.
