THE SULIS CLUB, CLAVERTON DOWN ROAD, BATH

Project: The Sulis Club

Title: Initial Preliminary Ecological Appraisal

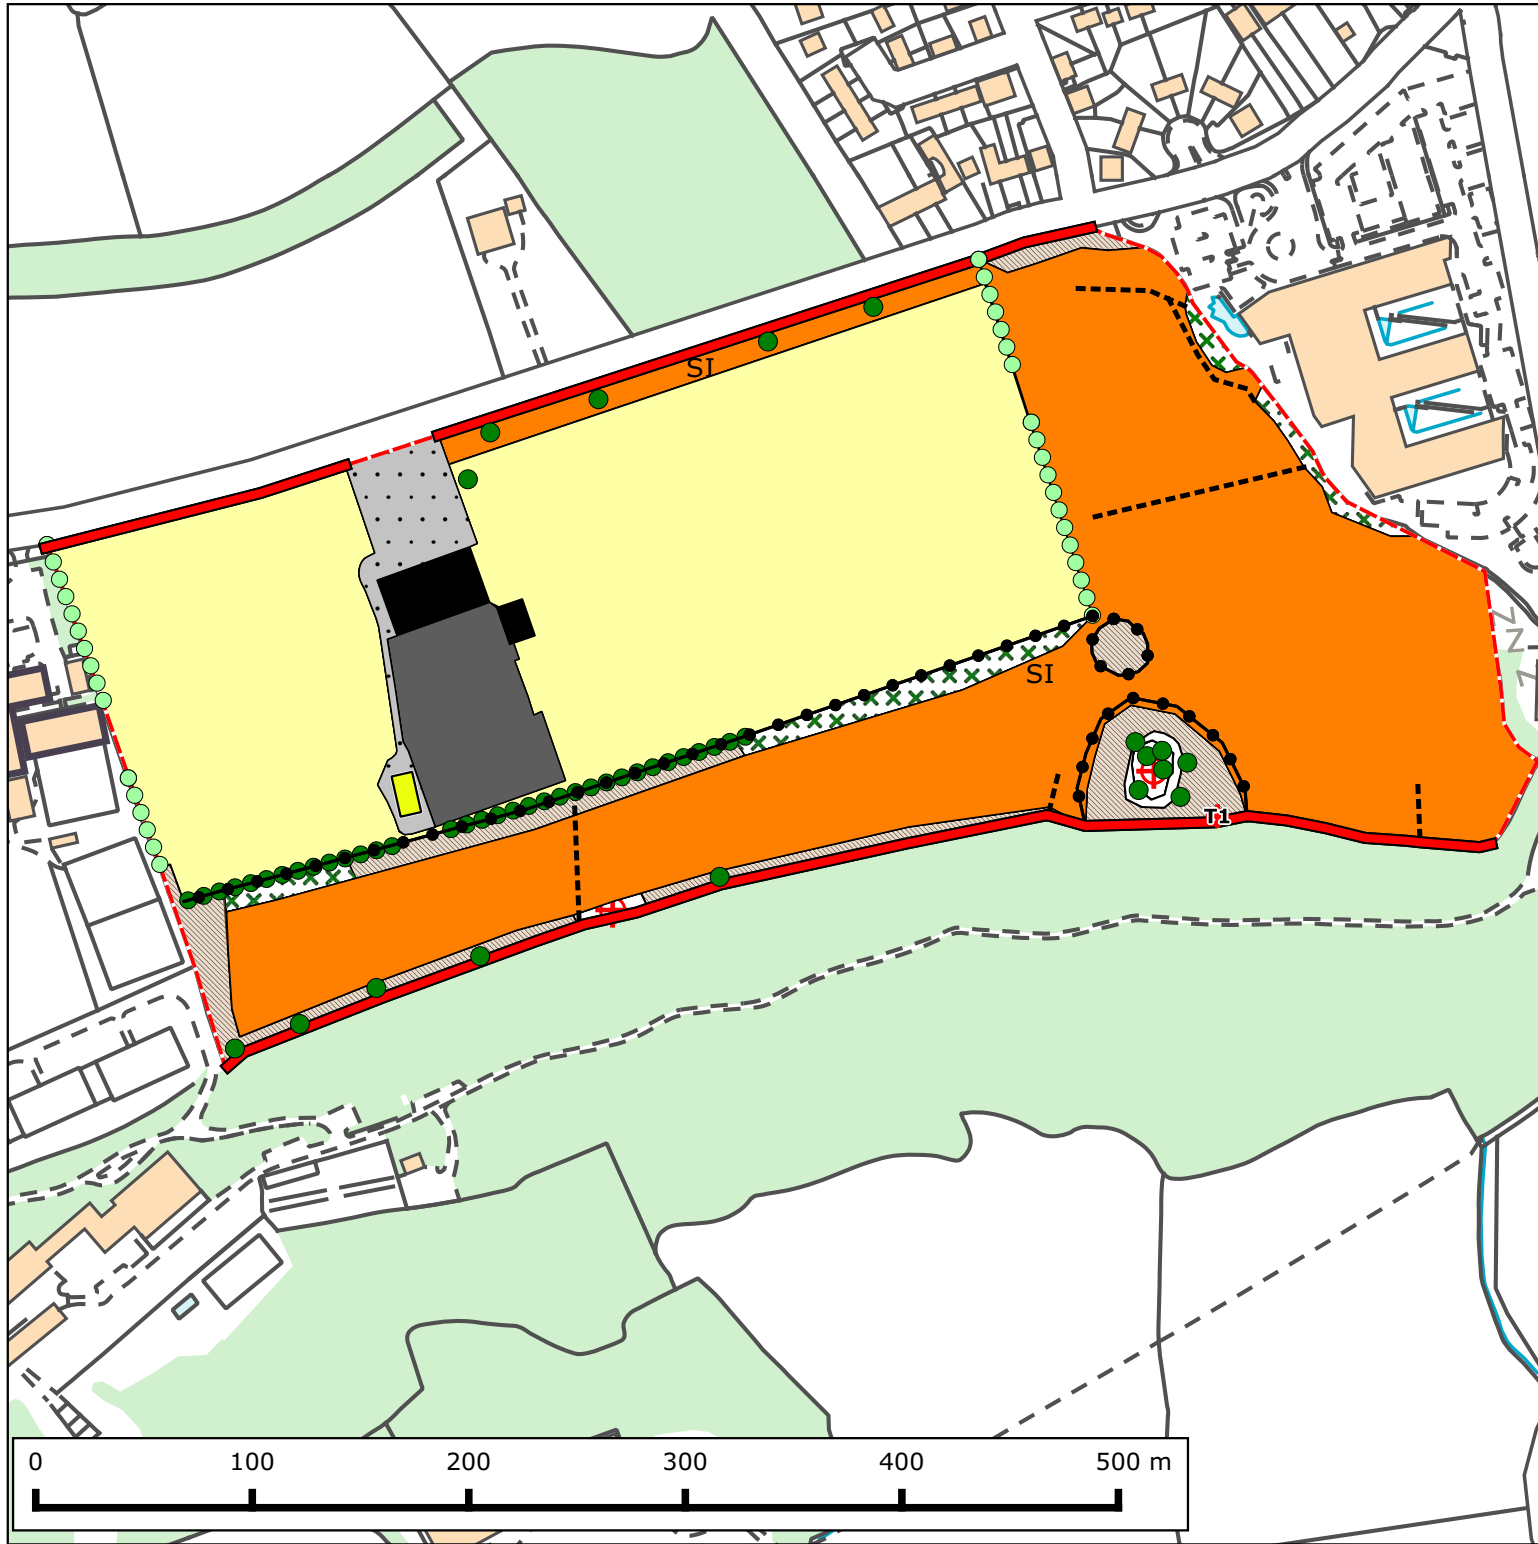
**Figure 1**

Ten habitats were present on site including; broadleaved scattered trees, coniferous scattered trees, stone walls, scattered scrub, semi-improved grassland, tall ruderals, amenity grassland, buildings and bare ground. Japanese Knotweed was also recorded on site along the southern boundary and on a large earth mound. Fly-tipping was noted, including large pipes which may support asbestos. All habitats are mapped on Figure 1.

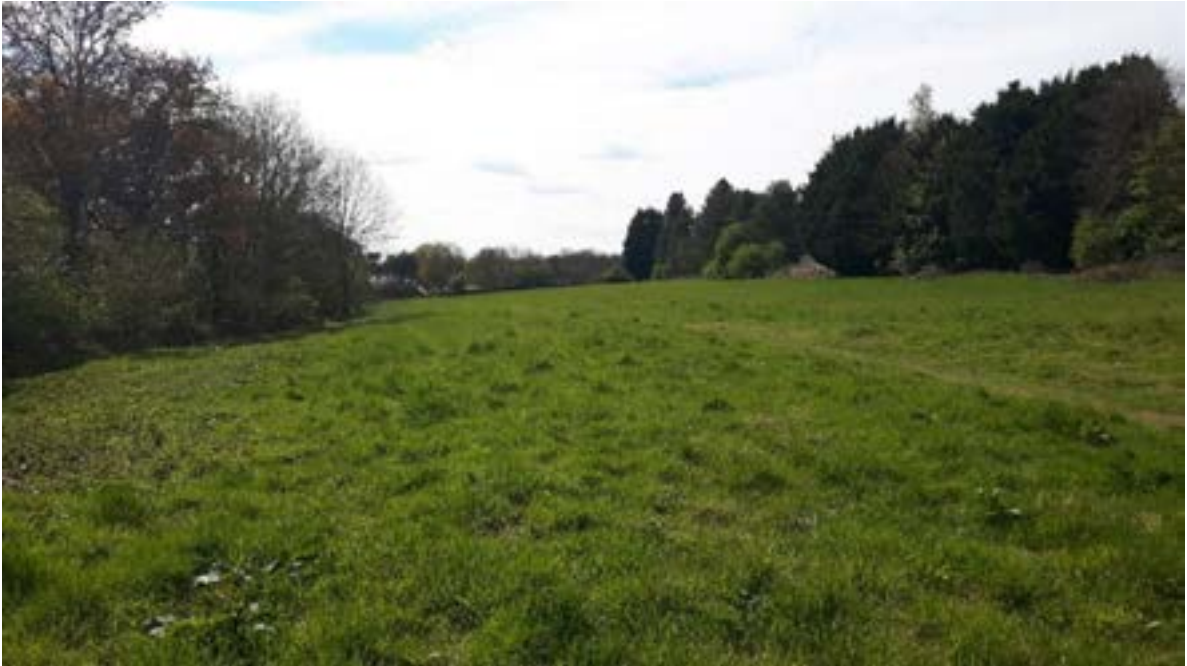
Broadleaved trees are present across the site and include ornamental planted trees located along the northern border and around the car park. Trees are also present along the southern boundary and between the sports pitches and semi-improved grassland, along the centre of the site (Plate 1 Annex 1). Tree species include; cherry, yew, oak and ash.

Plate 1: Broadleaved trees along the southern boundary and centre division

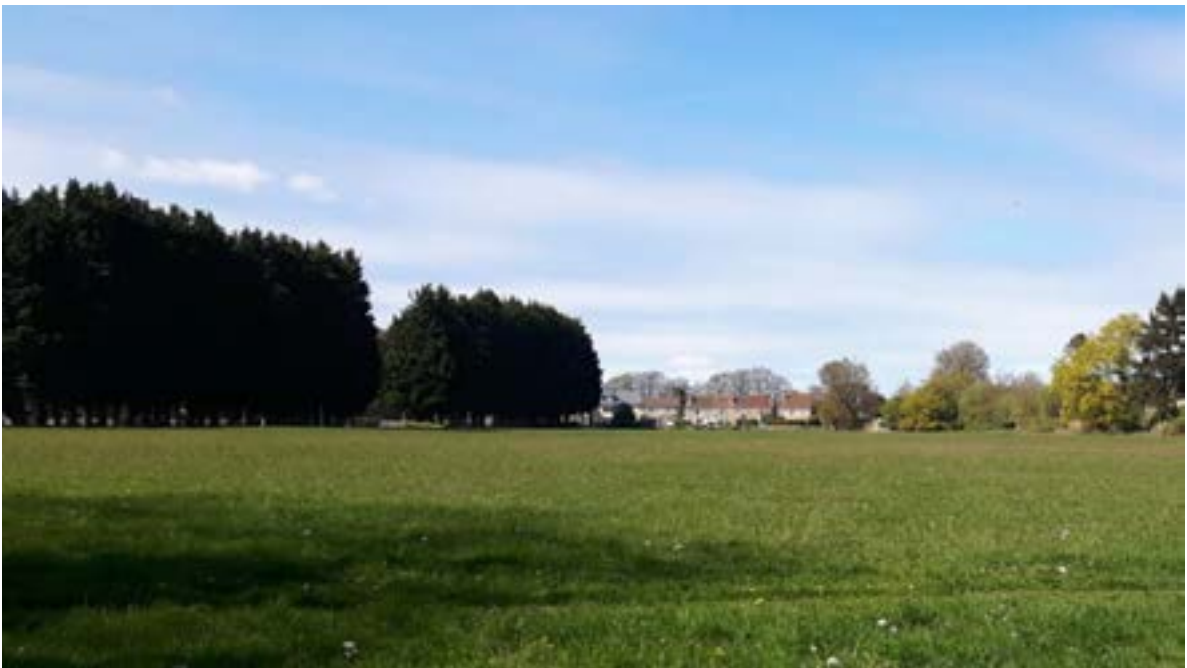
Coniferous trees are present across the site, predominantly along the eastern and western borders of the playing fields (Plate 2).

Plate 2: Coniferous trees along the eastern playing field boundary

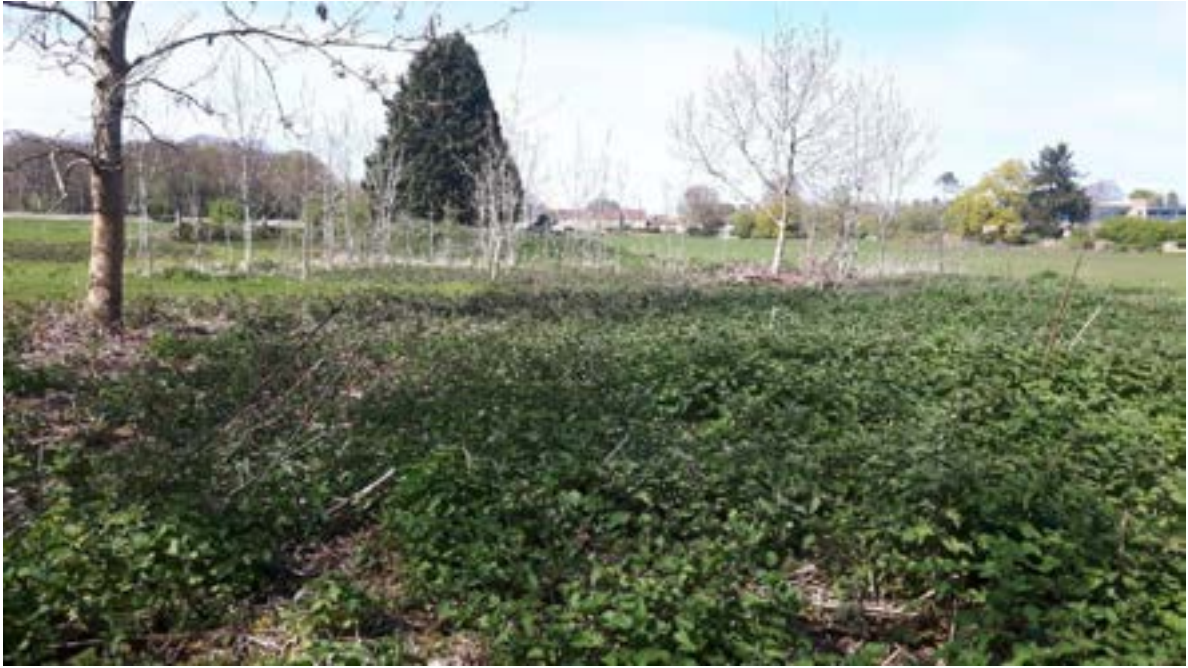
Plate 3: Larger grassland earth mound

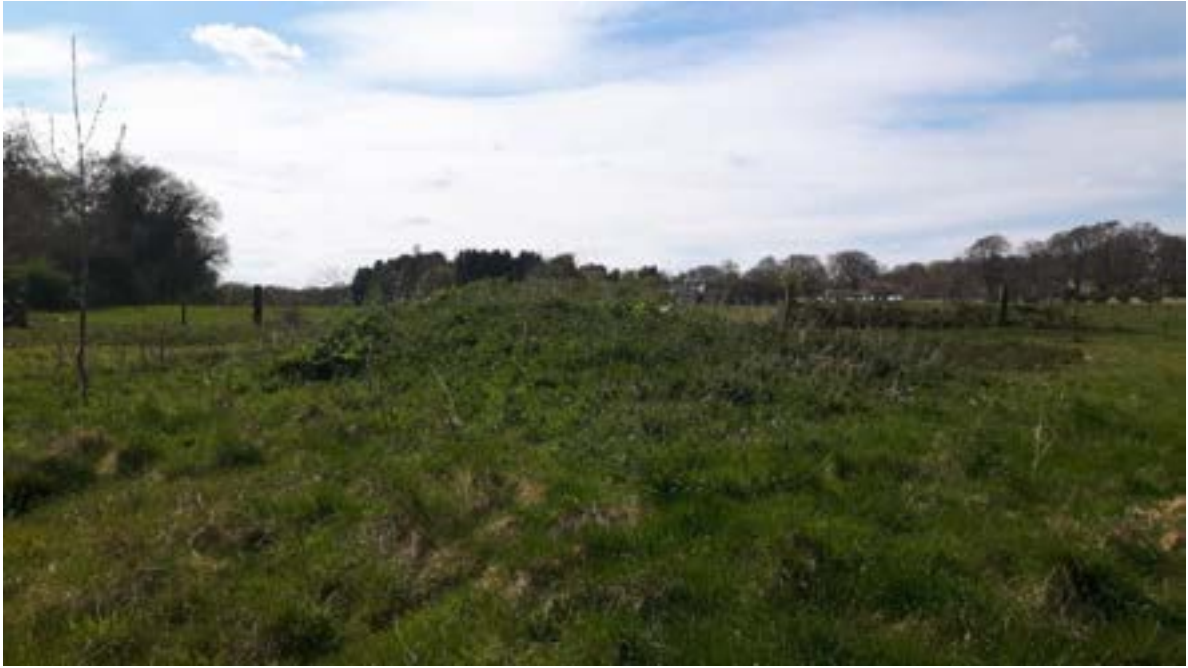
Three earth banks are present on site. One along the centre playing field boundary and two towards the south-eastern corner of the site. The former bank is south facing and is around 1m high, very steep and covered by grass and tree vegetation. The larger mound slightly further south is covered by grassland and tall ruderal vegetation as well as scattered immature trees (Plate 3). Deadwood piles and stones are present over the mound, as well as Japanese Knotweed (Plate 4). The smaller mound is steep and also grass covered (Plate 5). Both mounds have extensive excavations by rabbits.

Plate 5: Small earth mound

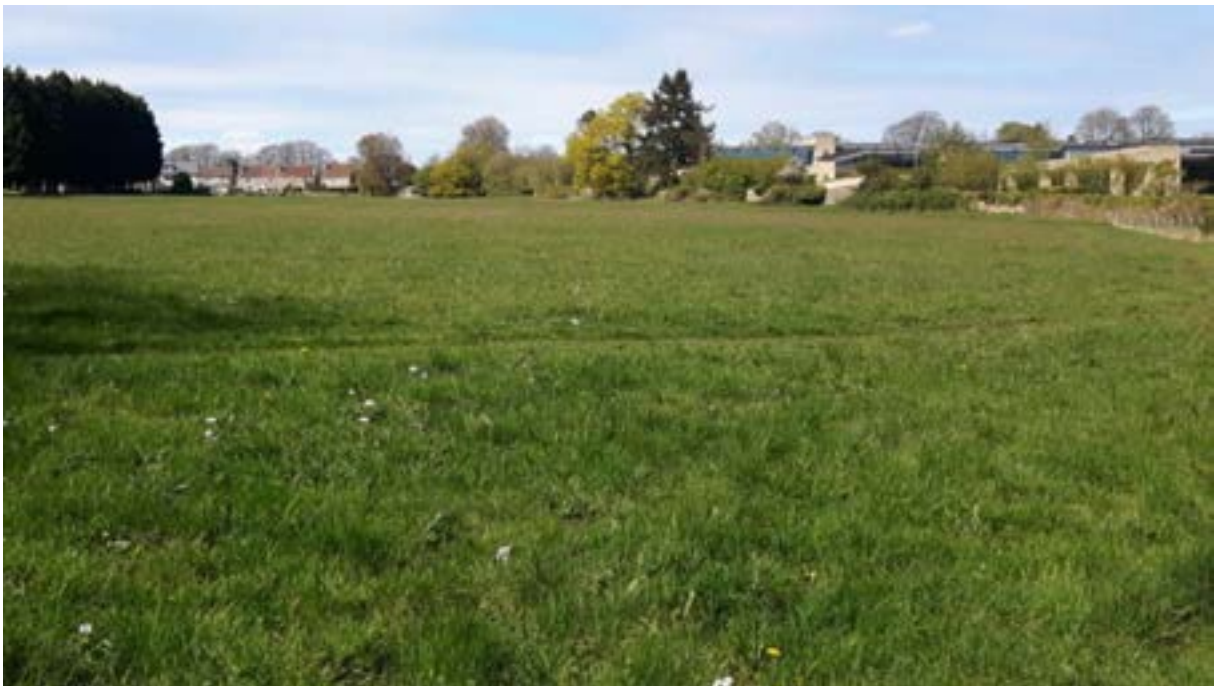
Semi-improved grassland surrounds the playing fields along the eastern and southern boundaries. The grass is unmanaged and supports a 30cm sward (Plate 6). Species present within the grassland includes; cleavers, perennial rye-grass, dock, dandelion, common nettle, white dead nettle, ribwort plantain, thistle, creeping buttercup and common daisy. Public footpaths run through this area of the site; one diagonally across the field to the east and one straight across the field to the south, running east to west.

Plate 6: Semi-improved grassland
